Stone Consulting & Design, P.C.

January 30, 2017

Subject: LBA Scrubber, 13' Dia. x 103' Tall
Tonawanda Coke Corporation Facility
External Inspection

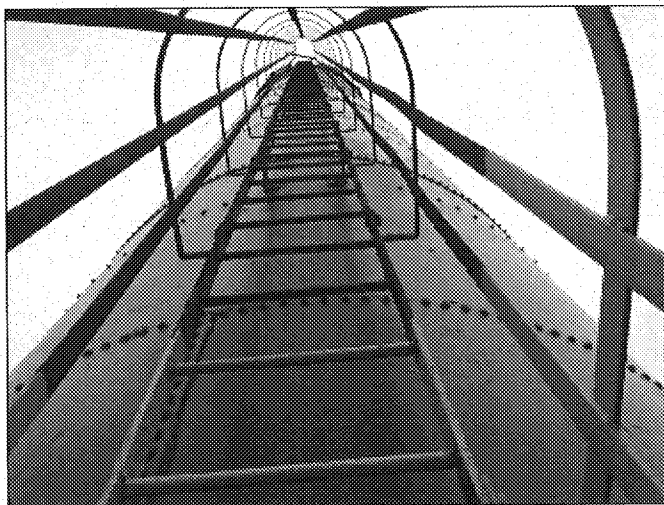
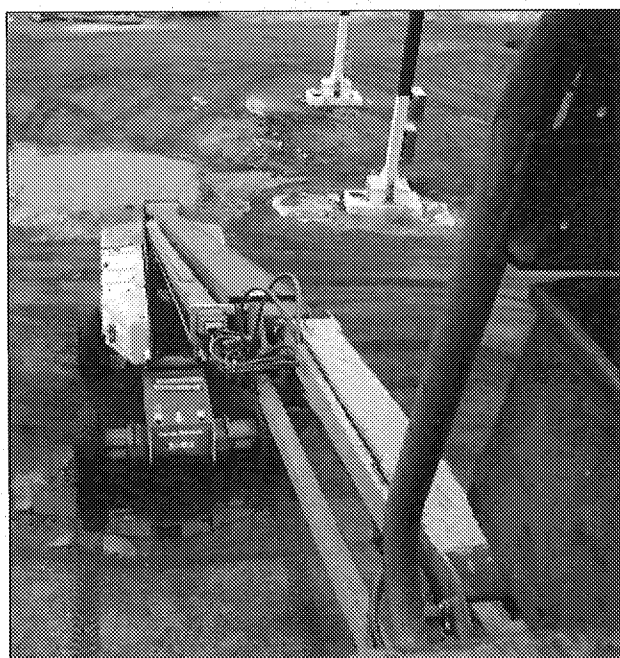
Per the request of Chuck Lauricella, I inspected the LBA scrubber structure during the afternoon of December 28, 2016 with the assistance of Ken Thrun, Plant Engineer, who arranged for the man lift and operator. My inspection consisted of inspecting the base, climbing the man ladder on the west side and using a man lift to inspect the structure from the opposite side.
